OMAP3530/25/15/03 Applications Processor
Silicon Revisions 3.1.2, 3.1, 3.0, 2.1, and 2.0

Silicon Errata

Literature Number: SPRZ278F
February 2008–Revised October 2010

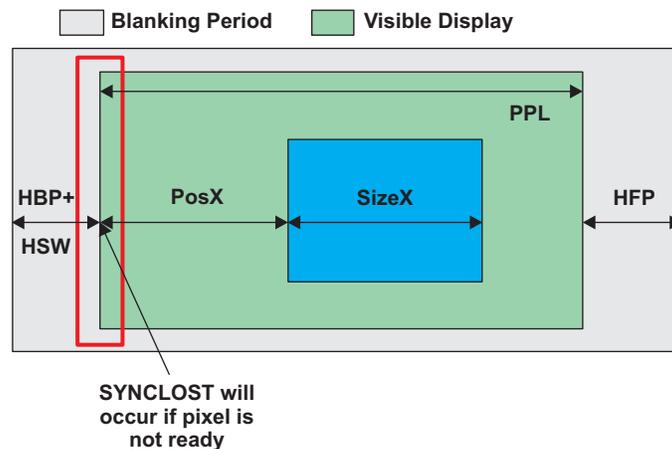
Figure 2. Synclost Interrupt

On OMAP35x Applications Processor silicon revisions 3.1.2 and earlier, Synclost interrupts are observed when performing downscaling and shifting resulting windows on the right of the LCD panel. This interrupt occurs because there is not sufficient time to load the necessary lines buffer before performing downscaling operation. DISPC video pipeline is expected to be ready with the pixels at the end of HSW+HBP period. This limitation is applicable on 3 and 5 taps configurations.

To ensure proper downscaling operation, these conditions should be met:

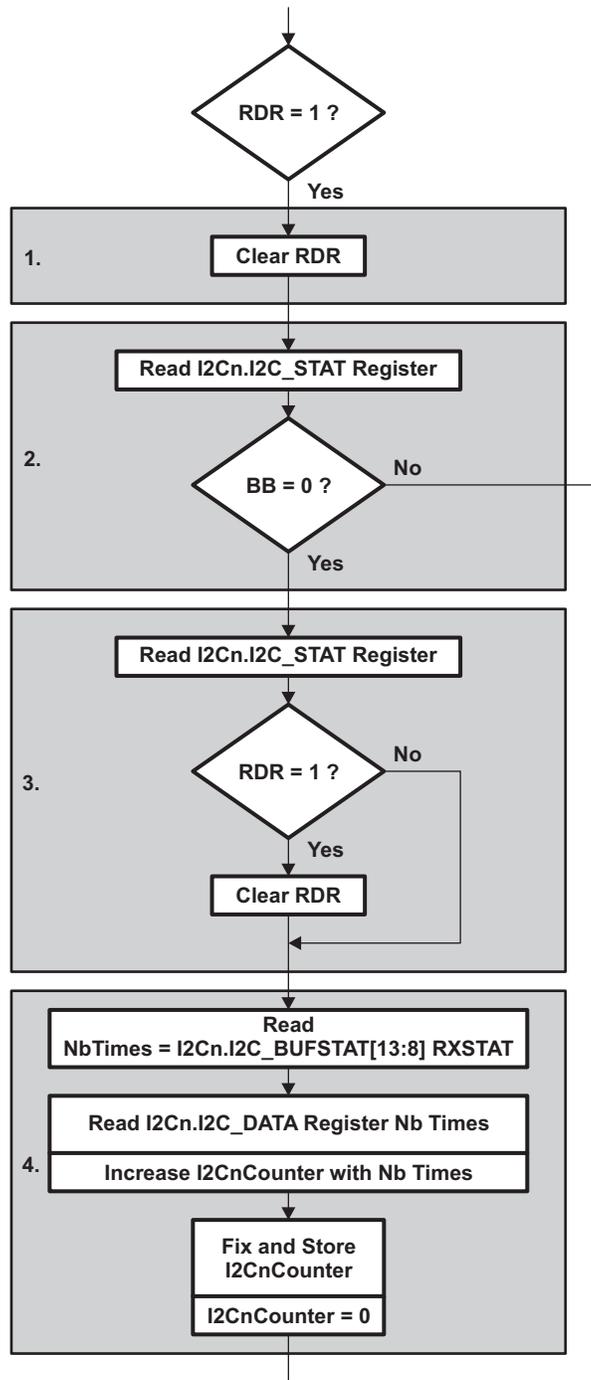
Figure 3. I2C Flowchart

Revision(s) Affected 3.1.2 and earlier**Details** Under certain rare conditions, the I2C_STAT[13].RDR bit may be set as well as the corresponding interrupt fire, even when there is no data in the receive FIFO, or the I2C data transfer is still ongoing. These spurious RDR events must be ignored by the software.**Workaround(s)** Software must filter out unexpected RDR pulses, using the flowchart illustrated in [Figure 3](#) when receiving an I2C RDR interrupt.

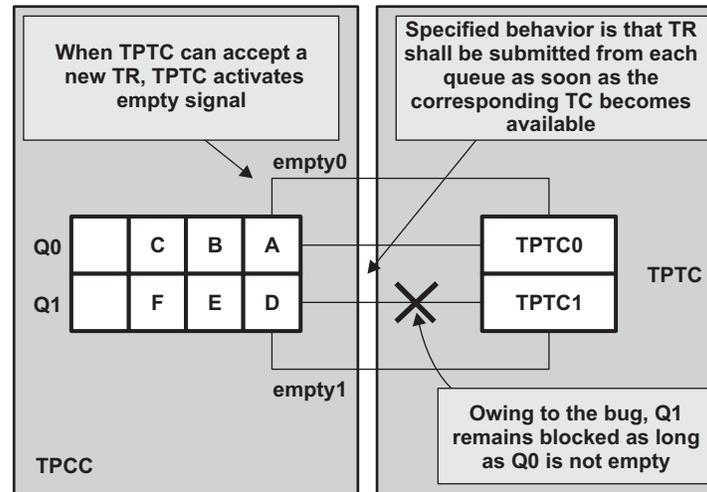
Figure 4. TR Submission Scheme
Workaround(s)

The EDMA channel controller (TPCC) has 2 event queues: Q0 and Q1. Each queue can be mapped to one of the two Transfer Controllers (TPTC): TPTC0 or TPTC1. As explained in the *OMAP35x Technical Reference Manual* (literature number [SPRUF98](#)), the events in each event queue will be extracted as soon as the corresponding TPTC is available for a new Transfer Request (TR) to be programmed into the TPTC. However, due to an issue in the IVA2.2 subsystem, the requests queued in Q1 cannot be submitted to their TPTC as long as Q0 is not empty.

Infrequent short transfers (e.g., latency critical synchronized transfers to/from peripheral) must be placed in Q0, and longer transfers (e.g., block copy) in Q1. For example, when a latency critical transfer is placed in EDMA and a longer transfer in QDMA, the following programming model will minimize the impact of this limitation:

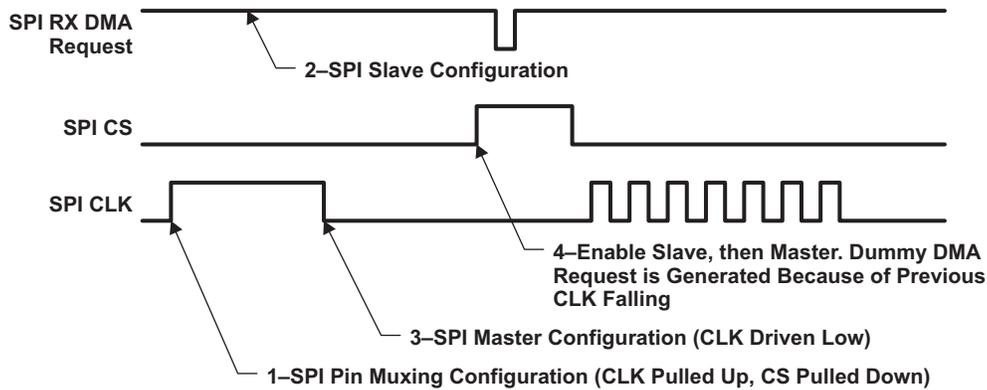
Figure 5. SPI Dummy DMA RX Generation

Details A dummy DMA RX request is generated as soon as the SPI is configured in *slave* mode and a SPI clock edge is detected. The dummy DMA RX request is generated during module configuration, when the module is not performing an SPI transfer. The dummy DMA RX request occurs as soon as the SPI interface signal sensitivity is changed compared to the default value.

The dummy DMA RX request is generated because the mechanism to avoid dummy data capture on a CS glitch is done regardless of channel activation.

Workaround(s) Avoid conditions where the SPI is in *slave* mode and the SPI clock toggles (see examples below).

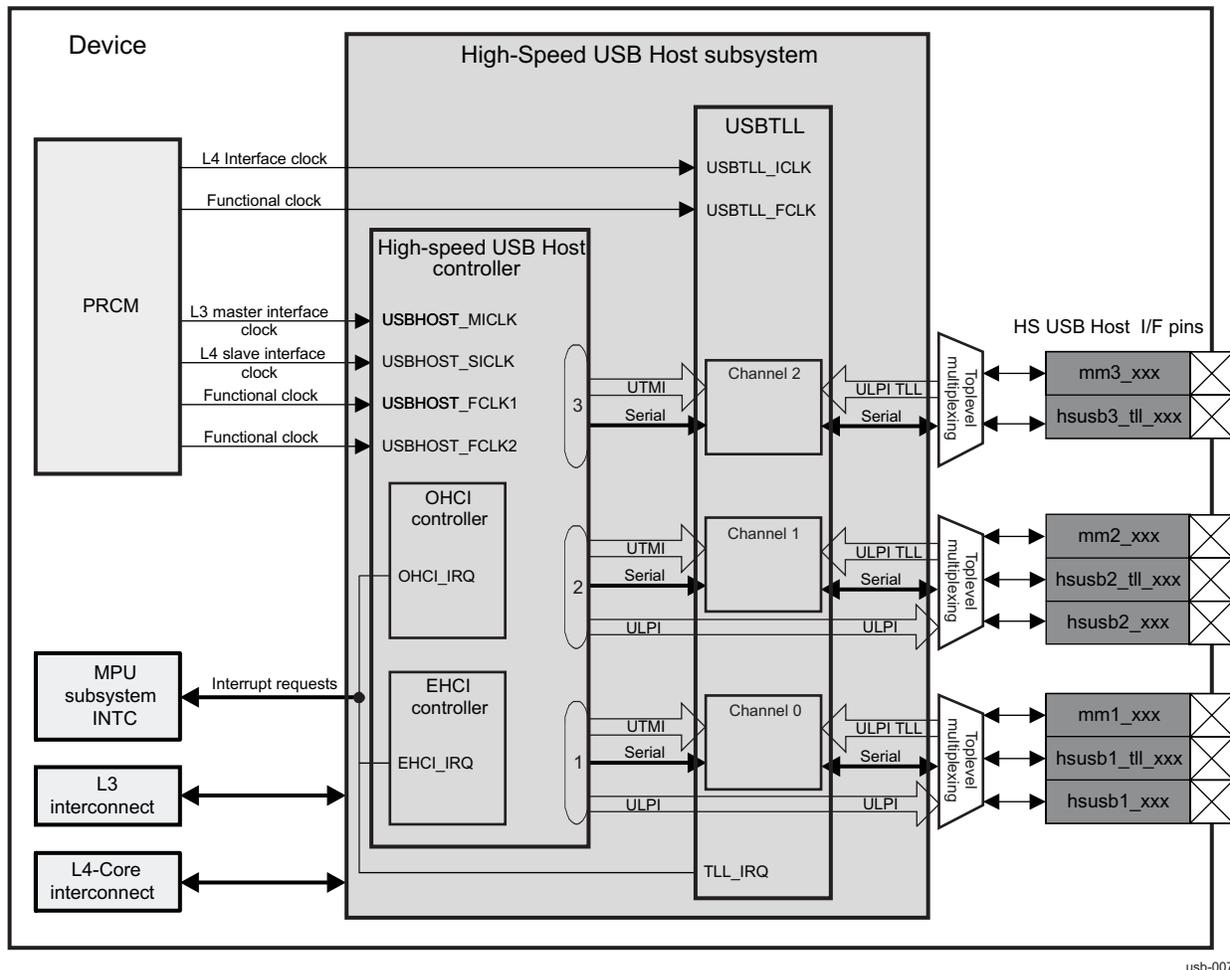
Figure 13. High-Speed USB Host Subsystem Highlight

Please note the following functional limitations when using the high-speed USB host subsystem:

- On silicon revision 3.0 and earlier, if one port is configured in the ULPI mode, then all other ports must use the same configuration. Therefore, the ports must be configured high-speed mode or full-speed/low-speed mode.
- USB Port 3 cannot operate in ULPI mode; it can only operate in serial or ULPI TLL mode. Furthermore, USB Port 3 is not available in the CUS package.

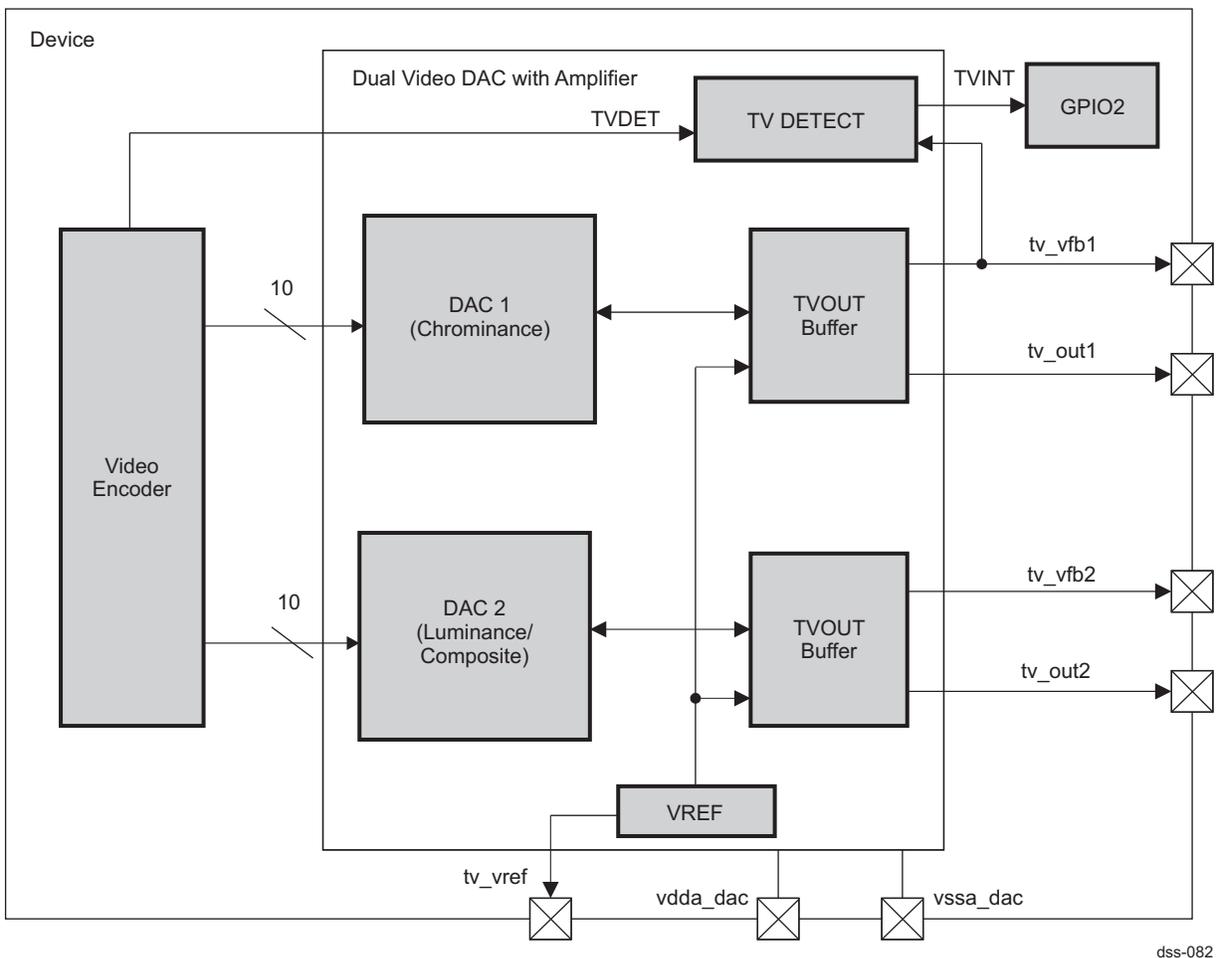
Figure 16. DAC Implementation

Furthermore, for proper TV detection in composite video mode (CVBS), DAC1 should be used for luminance and DAC2 for chrominance. Therefore, as a direct consequence of implementation, the TV detect feature is not available for composite video mode.

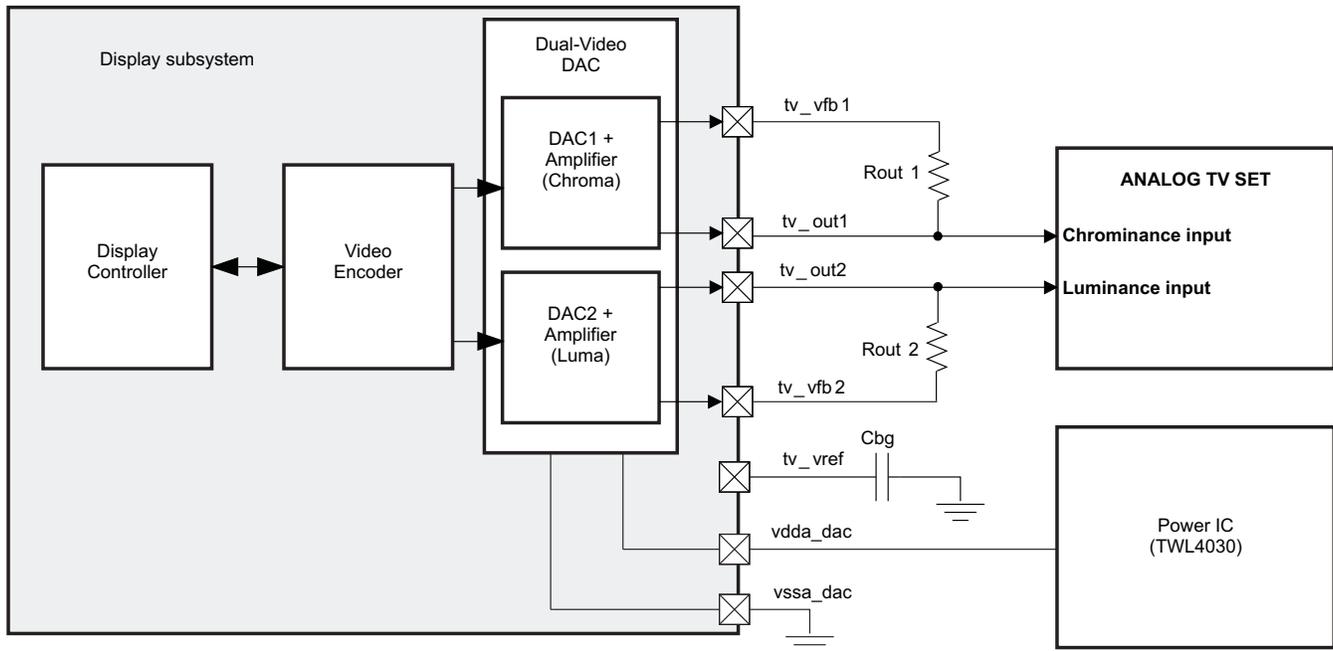
Figure 17. External Connection to TV Set

There is no workaround for the TV detect functionality. This feature is unavailable in *composite* video mode.

For proper TV out functionality, the external connection to the TV set must follow the implementation shown in [Figure 17](#).
