Errata AM263Px Sitara™ Microcontroller Silicon Revision 1.0

This document describes the known exceptions to the functional specifications (advisories). This document may also contain usage notes. Usage notes describe situations where the device's behavior may not match presumed or documented behavior. This may include behaviors that affect device performance or functional correctness.

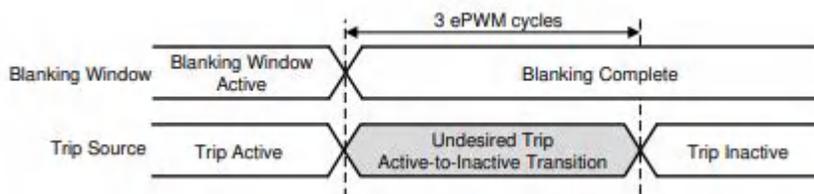
i2357 CONTROLSS-ePWM: An ePWM Glitch can Occur if a Trip Remains Active at the End of the Blanking Window

The blanking window is typically used to mask any PWM trip events during transitions which would be false trips to the system. If an ePWM trip event remains active for less than three ePWM clocks after the end of the blanking window cycles, there can be an undesired glitch at the ePWM output.

The following picture illustrates the time period which could result in an undesired ePWM output.

Avoid configuration of blanking window such that the trip input would fall in this range (1 cycle before and 3 cycles after the blanking window closure).

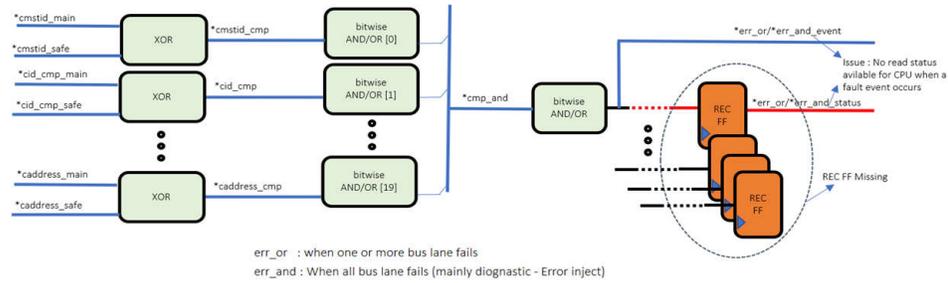
Figure 2-1.

Case 2: Log Registers have all zeros

Here the granular logs are not captured correctly and possible entities affected are R5F and L2 memory.

As Granular Error Status is not logged, the bus safety fault is detected only as an aggregated error event and the Granularity of diagnostics information will not be captured correctly.

Case 2: In the case where the logs are not captured correctly then for a) diagnostics no action needed and b) in case of actual failure in the application WarmResetn should be used.

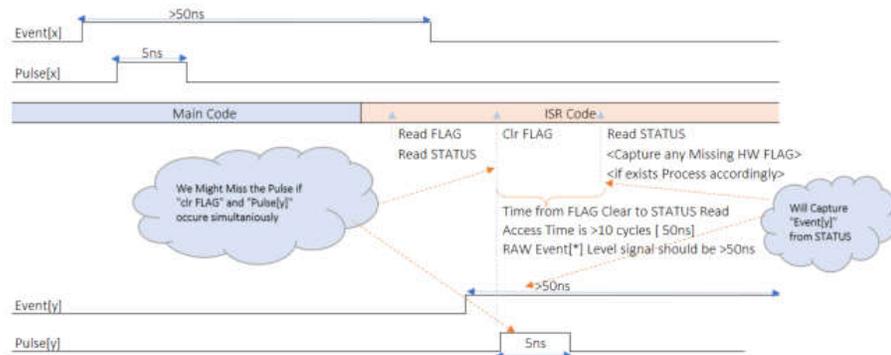
Potential race condition in capture registers resulting in events getting lost while other events in the same register are being cleared by writing to the register. Following registers are impacted by this issue:

WA -1 (For event widths > 50ns):

By default, level events (width >50ns) will be captured in "STATUS" Register, while performing "Clr Flag", if any new event from hardware is asserted at the same time, it will be missed in FLAG Register, However, STATUS register does capture such events missed in FLAG register. After completing "Clr FLAG", reading the "STATUS" register allows to capture/process any missed event based on "STATUS" read.

WA-1: ISR Sequence:
