Electrical Overstress Damage of TI 1394 PHY Devices

Connectivity Interface Solutions

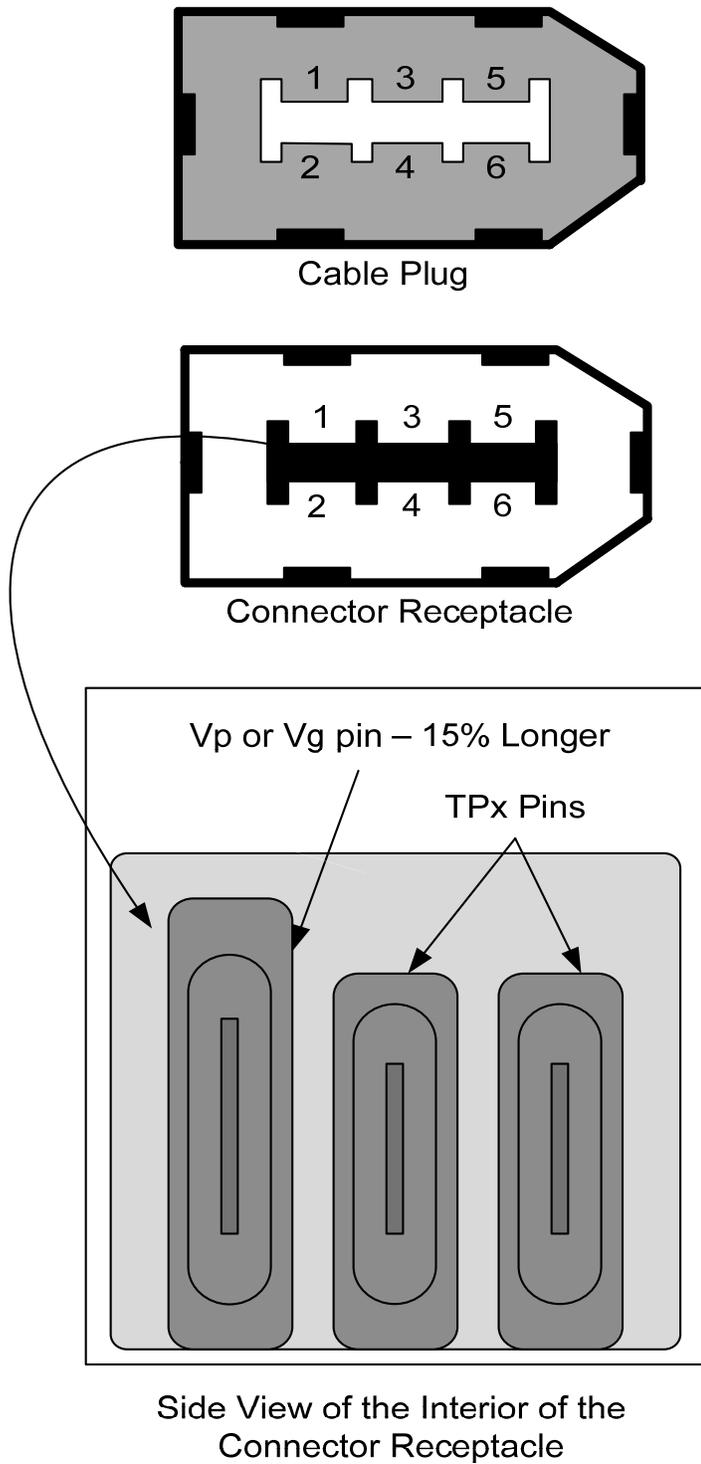
Figure 1. 1394 6-Pin Receptacle (Connector) and Plug (Cable) Diagrams

The Vp voltage appears on the TPx signal(s) because the data connection is used as a ground return path in lieu of the Vg connection. The high voltage and current on the return ground path can damage the TPx inputs of the 1394 PHY devices on both sides of the cable. ESD protection circuitry implemented inside the 1394 PHY device cannot protect against a late-Vg event because it is of longer duration and higher current than a typical ESD event. It should be noted that only one of the TPx connections is required for a late Vg event to occur. For example, a node with only Vp and TPB* connected would still be susceptible to late Vg damage.

PIN NUMBER	CONTACT NAME	COMMENT
1	Vp	Cable power
2	Vg	Cable ground
3	TPB*	Differential pair B
4	TPB	
5	TPA*	Differential pair A
6	TPA

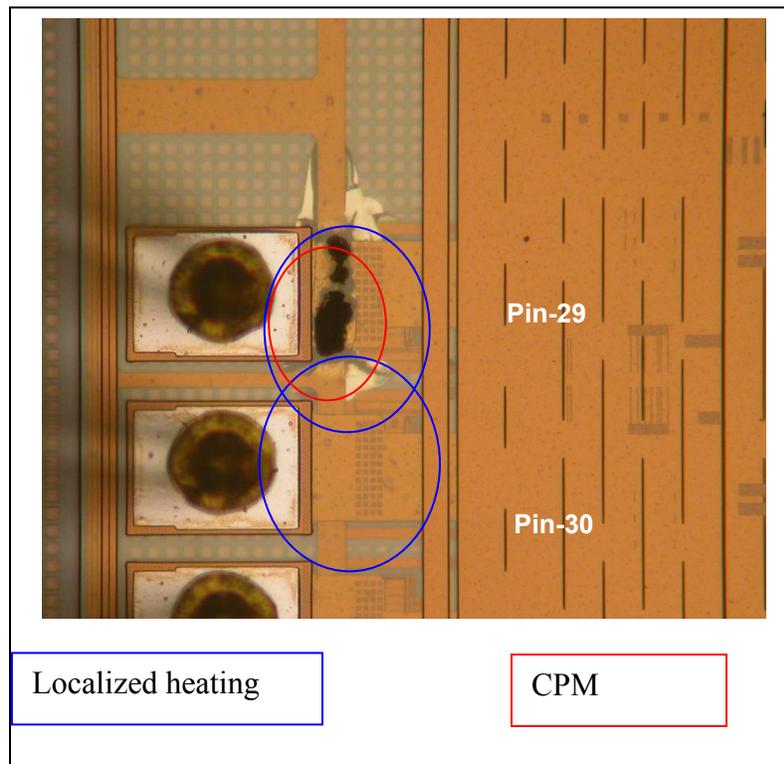
Figure 2. Optical Photo of the Localized Heating on the TPA* Pin (#29) and the TPA Pin (#30)

A full failure analysis of a 1394 PHY device that has experienced a late Vg event often shows a failure mechanism of damage to metal, polysilicone and die substrate resulting in the short to ground or open, consistent with electrical overstress. Excerpts from previous failure analyses of EOS damaged PHY devices are shown below. This is damage which is indicative of a late Vg event. Not every 1394 PHY damaged by a late Vg event will show the exact same damage pattern.

On this PHY device that was damaged by a late Vg event, liquid crystal analysis was performed, and localized heating was observed in the carbonized package material (CPM) and circuitry right off the bond pad. The TPA* pin was most likely shorted to the TPA pin through the metal extrusions.

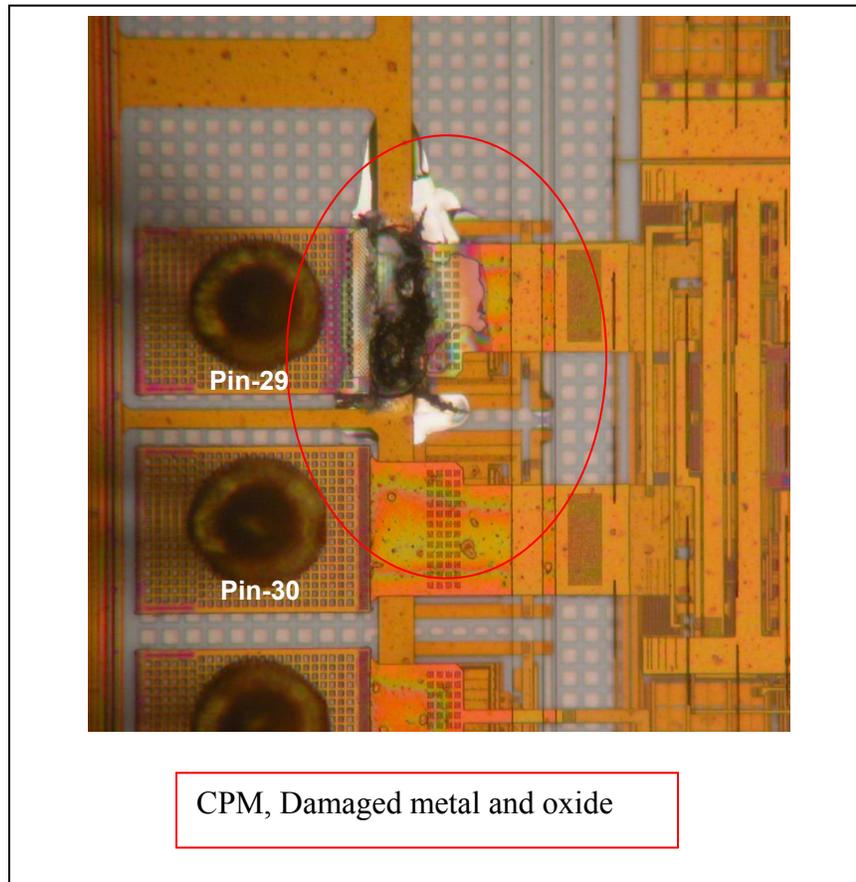
Figure 3. Optical Photo of the CPM, Damaged Metal and Oxide in the Area of Localized Heating

This 1394 PHY device was selectively deprocessed. The passivation and top metal were removed. Carbonized package material (CPM), damage to the metal and oxide were observed in the area of localized heating on TPA* pin (see Figure 3). The optical view at the Metal3 level shows visible evidence of localized heating at the bond pad for the TPA pin. The heating damage caused fused-open and re-flowed metallization

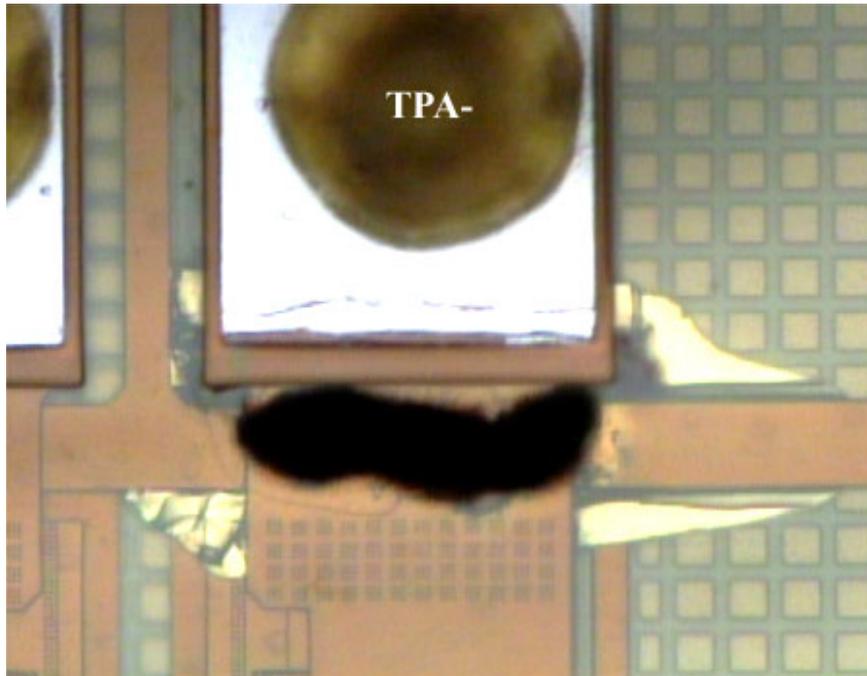
Figure 4. Optical Photo of a 1394 PHY Device Damaged by EOS

Another optical view from a different PHY device shows visible evidence of localized heating at the bond pad for the TPA pin. The heating damage caused degraded mold compound along with fused-open and re-flowed metallization.

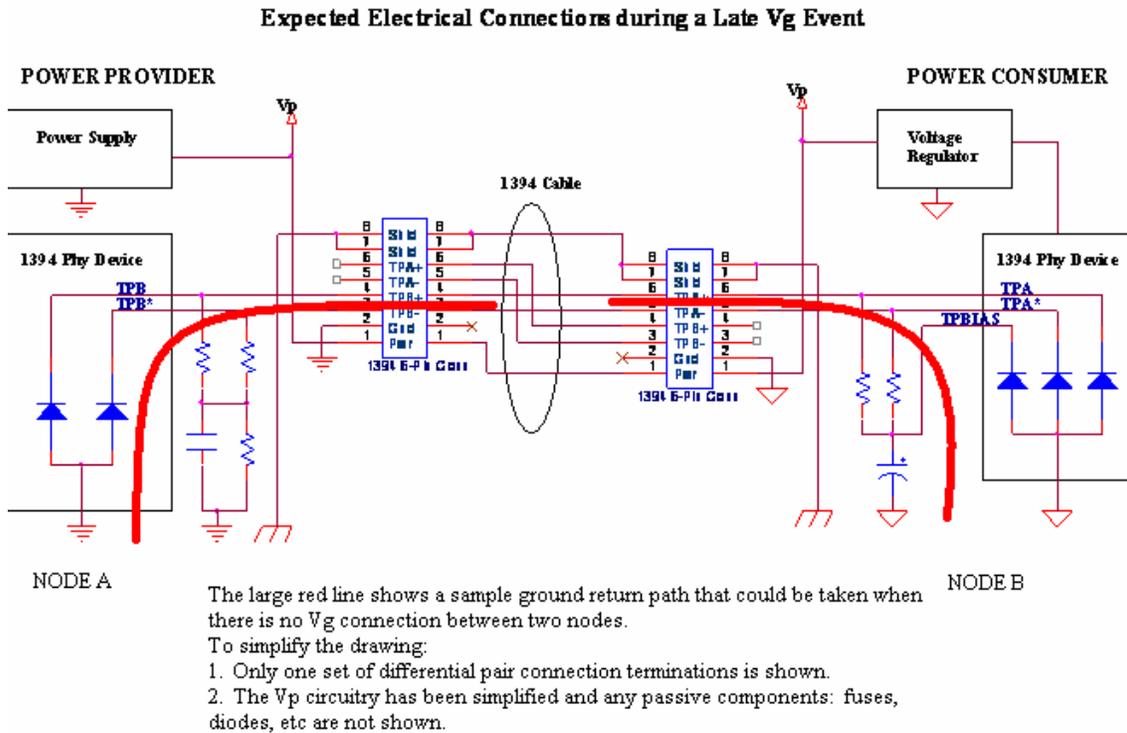
Figure 5. Late Vg Electrical Connections

Figure 5 shows a schematic of possible electrical connections between a power provider node (NODE A) and a cable power consumer (NODE B) during a late Vg event. For this explanation, it can be assumed that there is no direct ground connection between the two 1394 nodes anywhere in the design. The cable shield in the figure is shown as shorted to chassis ground with no connection to signal ground on either 1394 node.

The Vp connection can be assumed to occur first because it is a longer pin in the connector, thereby raising all signals on NODE B to the level of Vp. Once a data connection is made between the two nodes, the ground of NODE B is pulled down and the voltage regulator on NODE B engages. Since the data connection is acting as the ground return path, this forces the TPA/TPA* of NODE B in the figure to be pulled below the 1394 PHY device ground. This low voltage is most likely in excess of the absolute maximum rating input voltage rating of -0.5 VDC on the 1394 PHY device and can result in damage to the 1394 PHY device on NODE B.

As the voltage regulator of NODE B begins driving out, additional current is returned through the data connection raising the voltage on the TPB/TPB* signals of NODE A in the example. Depending on the cable power voltage of the system, the voltage on TPB/TPB* could be in excess of the absolute maximum input voltage rating of $V_{DD} + 0.5$ VDC on the 1394 PHY device and can result in damage to the 1394 PHY device on NODE A.

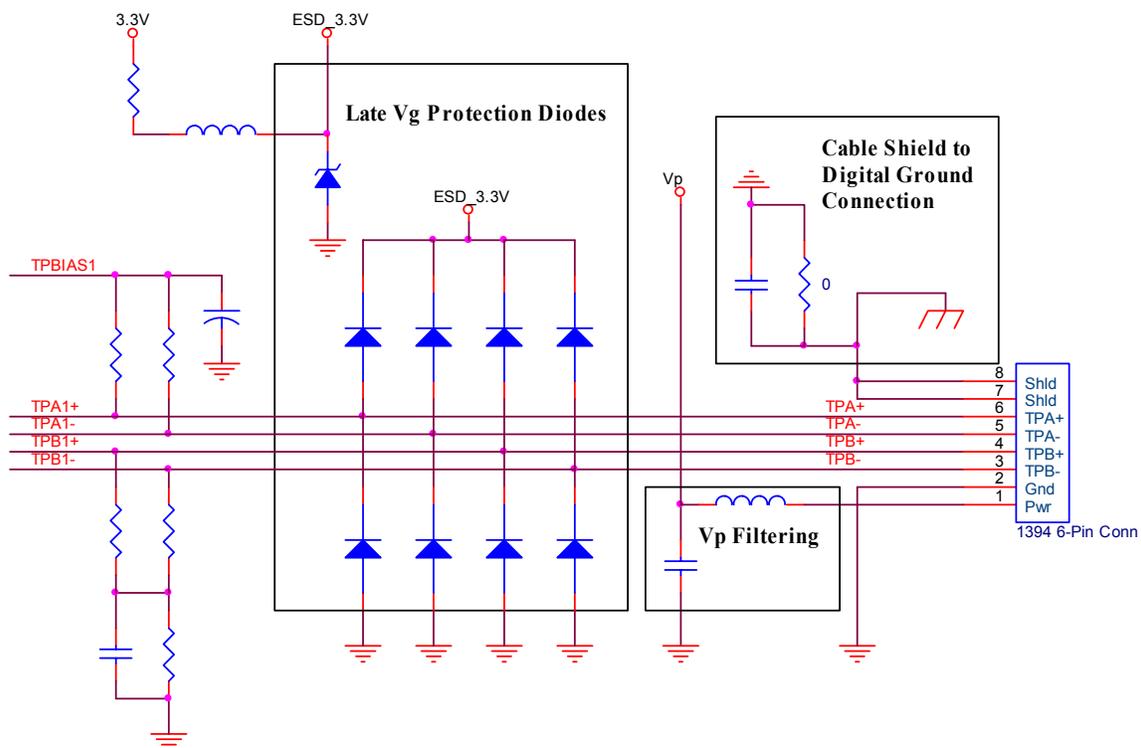
Figure 6. Late Vg Protection Circuitry

Another option is to add low capacitance high-speed switching double-diode circuits like the BAV99 to each of the TPx lines to protect them from damaging voltages. A Zener diode biased via a current limiting resistor should also be added to provide a path for any late Vg voltage to return to ground. For a S800 application, the diodes on the TPx signals should be extremely low capacitance or they will affect signal integrity. Figure 6 shows how these preventative measures can be implemented in a typical 1394 application.

One easy-to-implement suggestion is to provide an alternate low-impedance ground return path by shorting the chassis ground of the cable shields to digital (signal) ground. This can be done through a low impedance filter to prevent excess noise if needed.

In addition, it is important for both EMI and ESD concerns to have some low pass filtering on Vp near the connector. TI recommends a ferrite bead (up to 1000 ohms at 100 MHz) with a capacitor. These components will slow the current rush and potential voltage spike during cable connection thereby reducing the effects of a late Vg event.
