OMAP3530/25/15/03 Applications Processor
Silicon Revisions 3.1.2, 3.1, 3.0, 2.1, and 2.0

Silicon Errata

Literature Number: SPRZ278F
February 2008–Revised October 2010

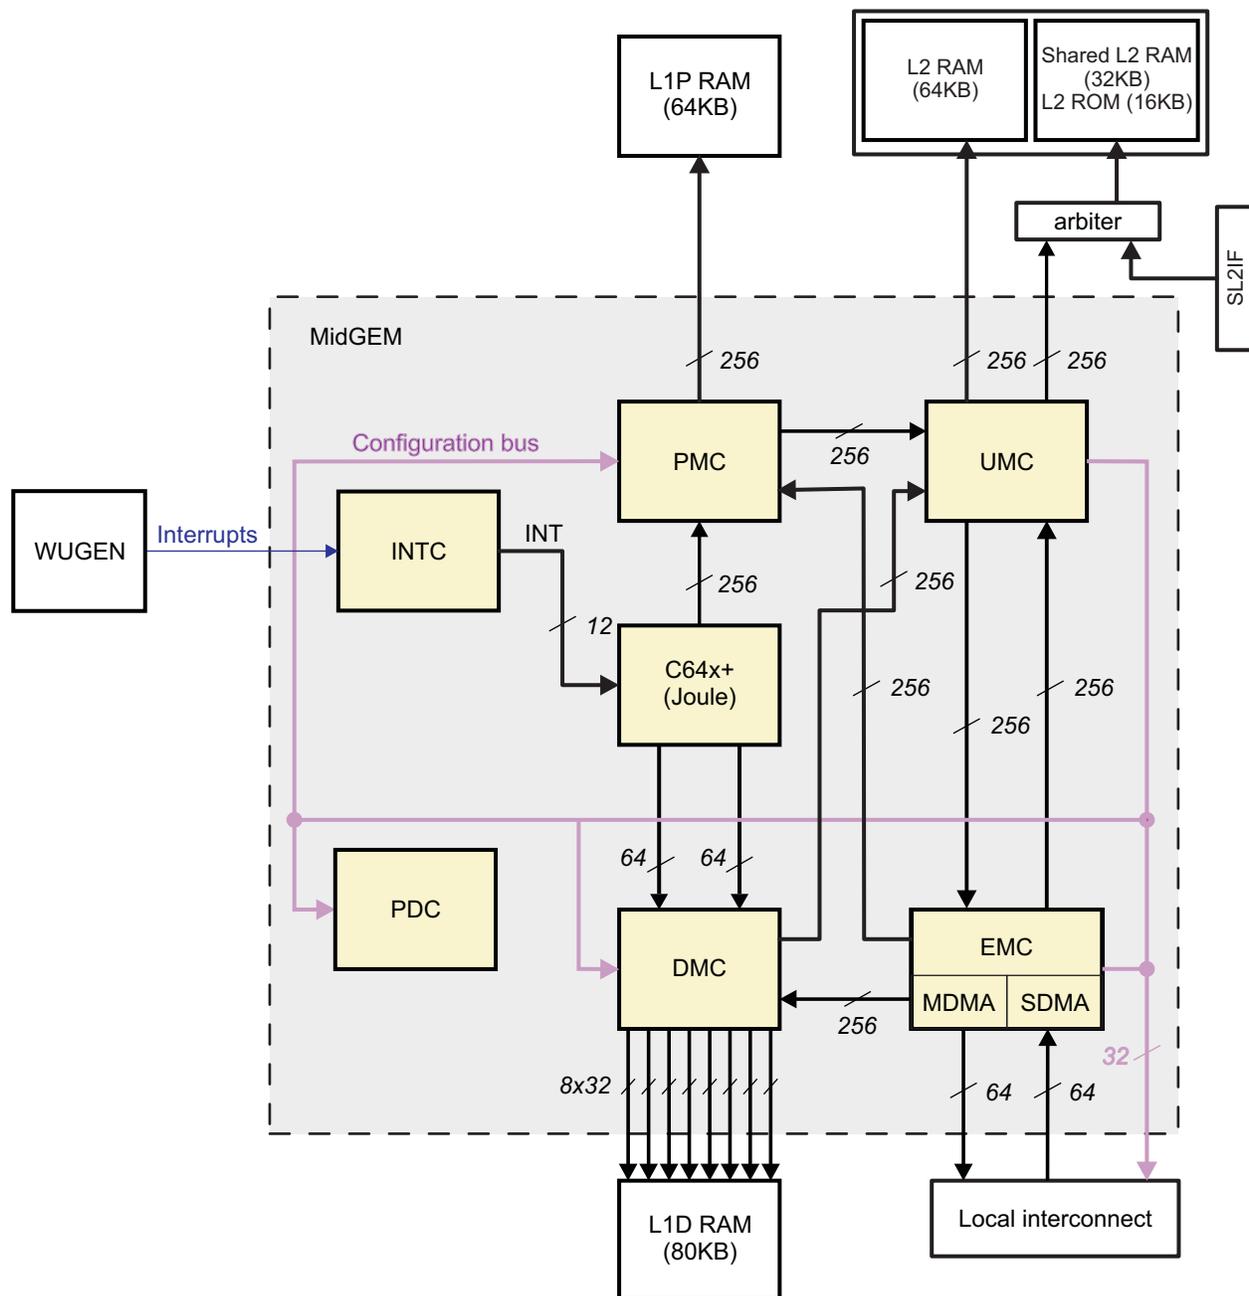
Figure 8. C64x+ Megamodule Block Diagram

Ideally the MDMA and SDMA/IDMA paths operate independently with minimal interference. Normally MDMA accesses may stall for extended periods of time (clock cycles) due to expected system level delays (e.g. due to bandwidth limitations and/or DDR memory refreshes). However, due to the exception, there are cases where SDMA and/or IDMA accesses to L2/L1 experience an additional/unexpected stall during the normal stalls seen by the MDMA interface. For latency sensitive traffic, the SDMA stall can result in missing real time deadlines.

NOTE: SDMA/IDMA accesses to L1P/D will not see any unexpected stall if there are no SDMA/IDMA accesses to L2 (both cache/SRAM and shared SRAM). This is because unexpected SDMA/IDMA stalls to L1 happen only when they are pipelined behind L2 accesses which experience stalls due to the exception.

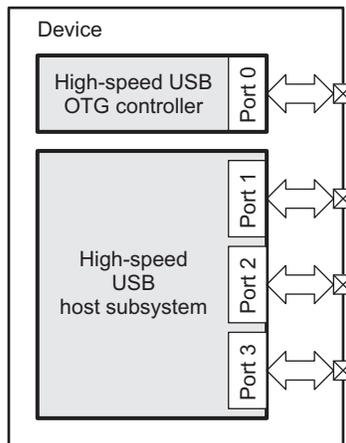
Figure 11. OMAP35x USB Modules

On OMAP35x Applications Processor silicon revisions 3.0 and earlier, as shown in [Figure 11](#), the OMAP35x device includes a high-speed universal serial bus (USB) OTG controller and a high-speed USB host subsystem.

Note: USB Port 3 is not available on CUS package.
